Eliseparts Gear Linkage Kit 1 S2 Fitting instructions

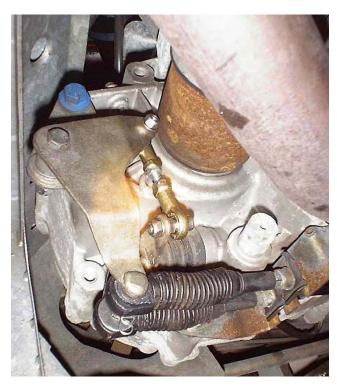
If you can't reach 2nd, then you need to shorten the distance between the rod-ends, if you can't reach 5th, you will need to lengthen the link. To adjust the link, un-bolt the lower rod-end from the selector bracket, then turn clockwise (to shorten) or anti-clockwise (to lengthen), then re-fit.

When you are completely satisfied you have correctly adjusted the joints, make sure they are all tight, and re-fit the under-tray and test drive!
