Eliseparts Gear Linkage Kit 1

S2 Fitting instructions

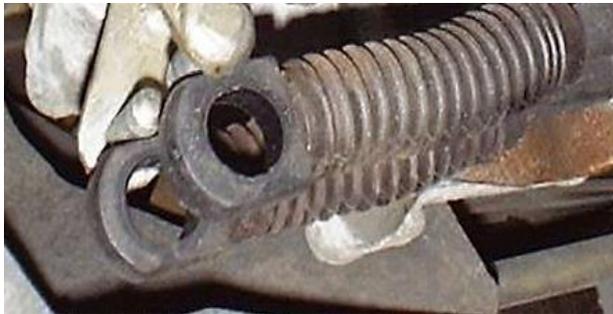
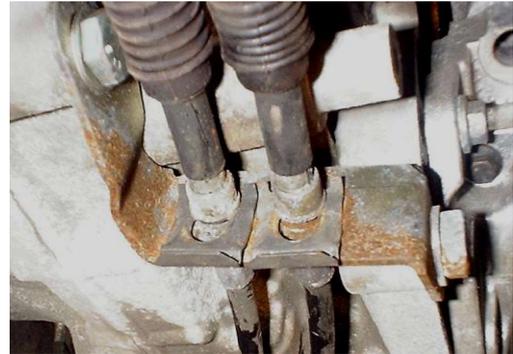
1. Raise the rear of the car so that you can comfortably work underneath it, making sure that it is secure.
2. Remove rear under-tray. This has 5 bolts at the rear edge, 6 at the edge of the front sides (3 each side) and 4 in the middle.
3. Remove the two gear cable clips (shown right), being careful no to loose them as they spring out.

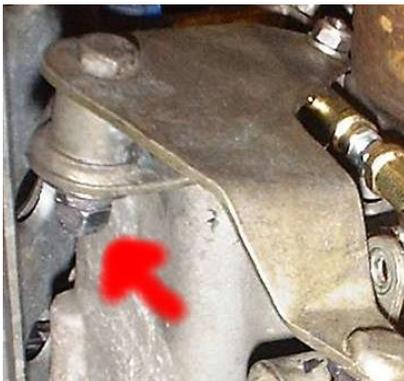
4. Push out the old rubber bushes from the ends of the gear cables, then, move the cable out of the way.
5. Remove Nyloc and Lock nut from bell crank, (using 2x10mm spanners), and push the link clear from the bracket.

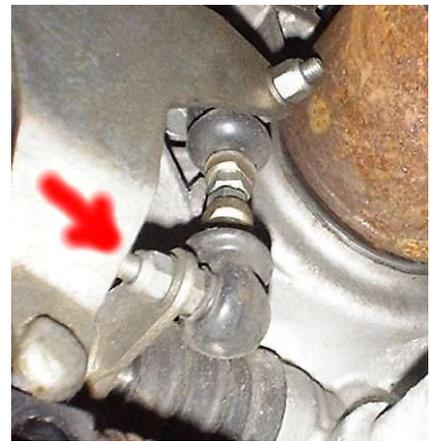
6. Remove the bell-crank nuts (shown left), this is a Nyloc and half nut. When removed, the bell-crank should be slid off with the old joints attached.

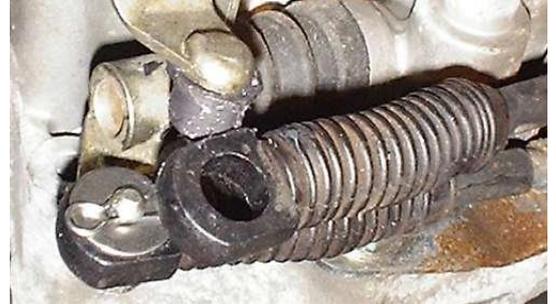
11. Push the gear cable Nylatron bushes over the cleaned up pivot points. Once the cable ends have been greased, these can then be pushed over the Nylatron bush, followed by the M8 washer and secured by the 'R' clip (as shown).NB* Grease all surfaces liberally.

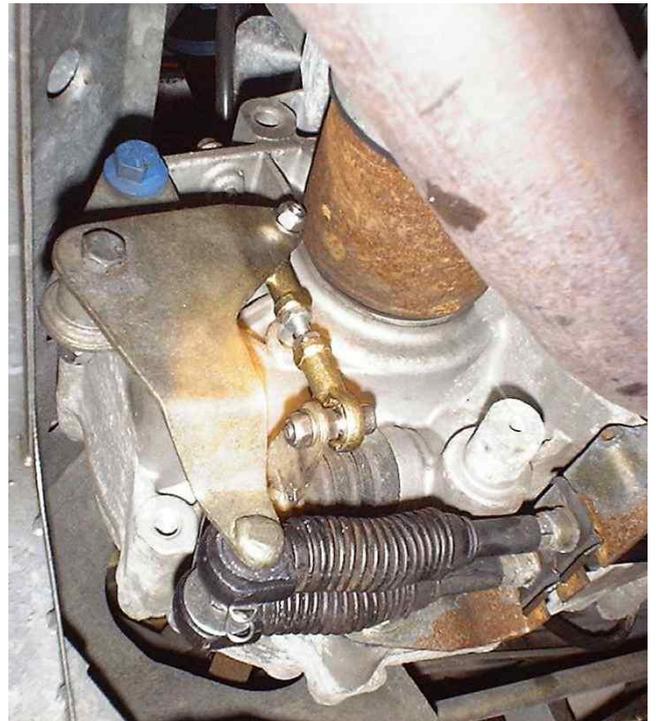
12. Replace the cable clips. The whole assembly should look something like this.

All that needs to be done now is to check that you can reach all the gears; this is best done with an assistant. Whilst watching the linkage get the assistant to select 2nd Gear, and then 5th gear. If all is well, tighten up the lock-nuts between the rod-ends, making sure that they can still articulate.

If you can't reach 2nd, then you need to shorten the distance between the rod-ends, if you can't reach 5th, you will need to lengthen the link. To adjust the link, un-bolt the lower rod-end from the selector bracket, then turn clockwise (to shorten) or anti-clockwise (to lengthen), then re-fit.
